SOUTH FORK CLEARWATER RIVER **HABITAT** ENHANCEMENT
CROOKED AND RED **RIVERS**

ANNUAL REPORT - 1989

U. S. **Forest** Service
Nez **Perce** National **Forest**

Contract Number **DE-AI79-84BP16475**
Project Number 84-5

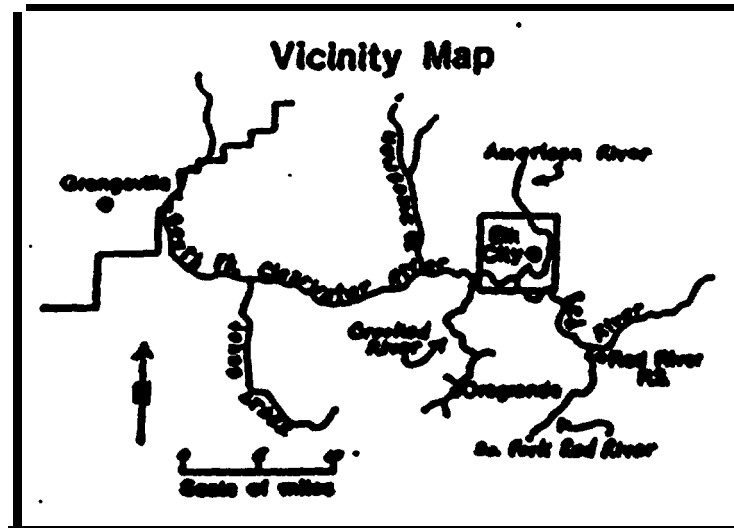
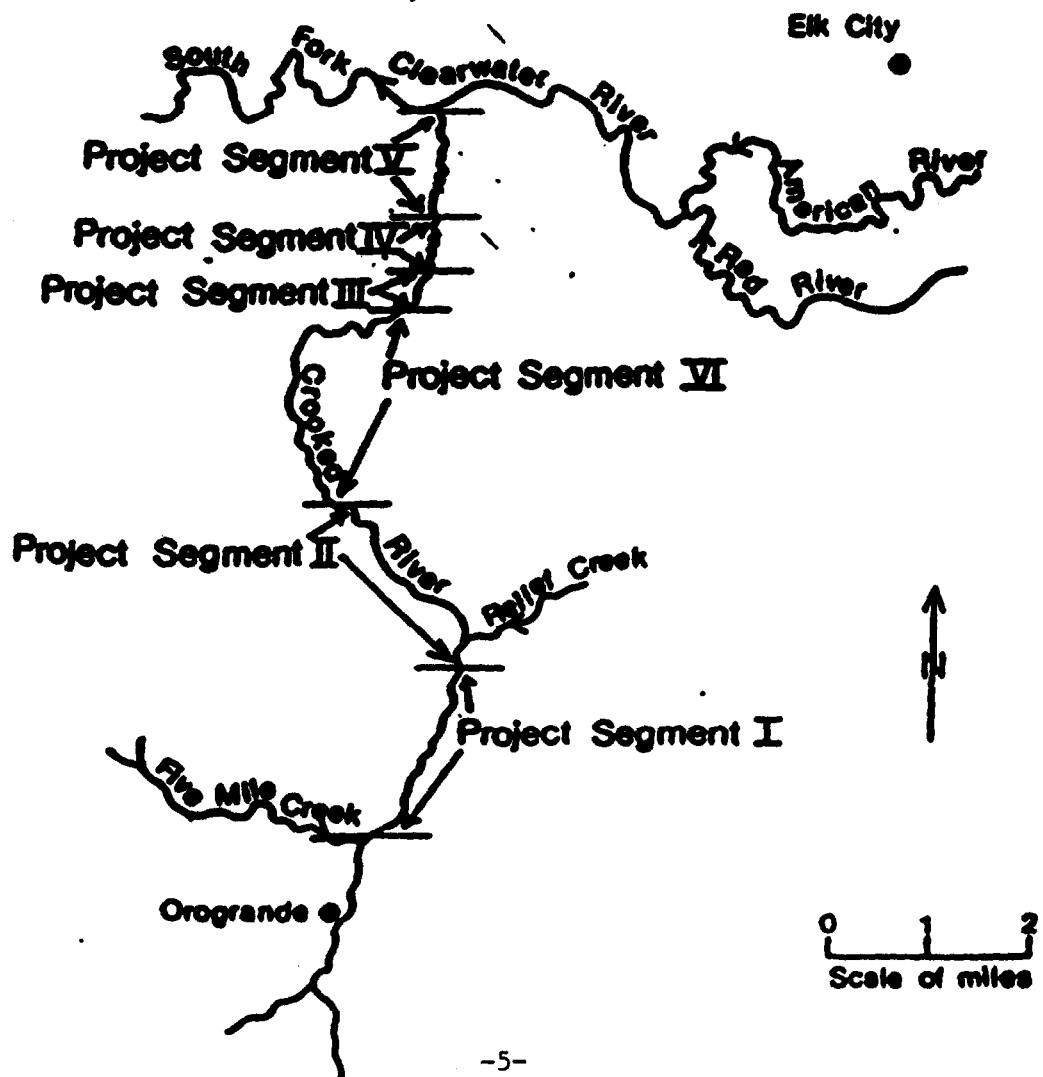
FIGURE 1

The Nez Perce National Forest project areas are located on the Elk City and Red River Ranger Districts. The 1988 Crooked River project areas were located in Project Segments III and IV (Figure 1). All work was performed on U.S.F.S. land. There was some off-channel work performed in this area of Crooked River during 1986-1987.

In 1989, enhancement work was performed in project segments I, III, IV, and V (Figure 1). Because the channel in the lower section (segments III, and IV) of Crooked River was left in a over-meandering condition, the stream has to travel a longer distance in the same vertical drop as the natural system did. This has created an extremely low gradient (0.5-0.8%) in this section (segments III and IV) of river. Although there is a high amount of spawning gravels and pools in segments III-V, the low gradient adversely effects then, Sediment transported through the upper higher gradient areas are deposited out when they reach this meander section of river. Spawning gravels are also effectively "trapped" in this low gradient area. The low gradient and high sediment deposition prevent gravels from being sorted into a utilizable form for salmonid spawning use.

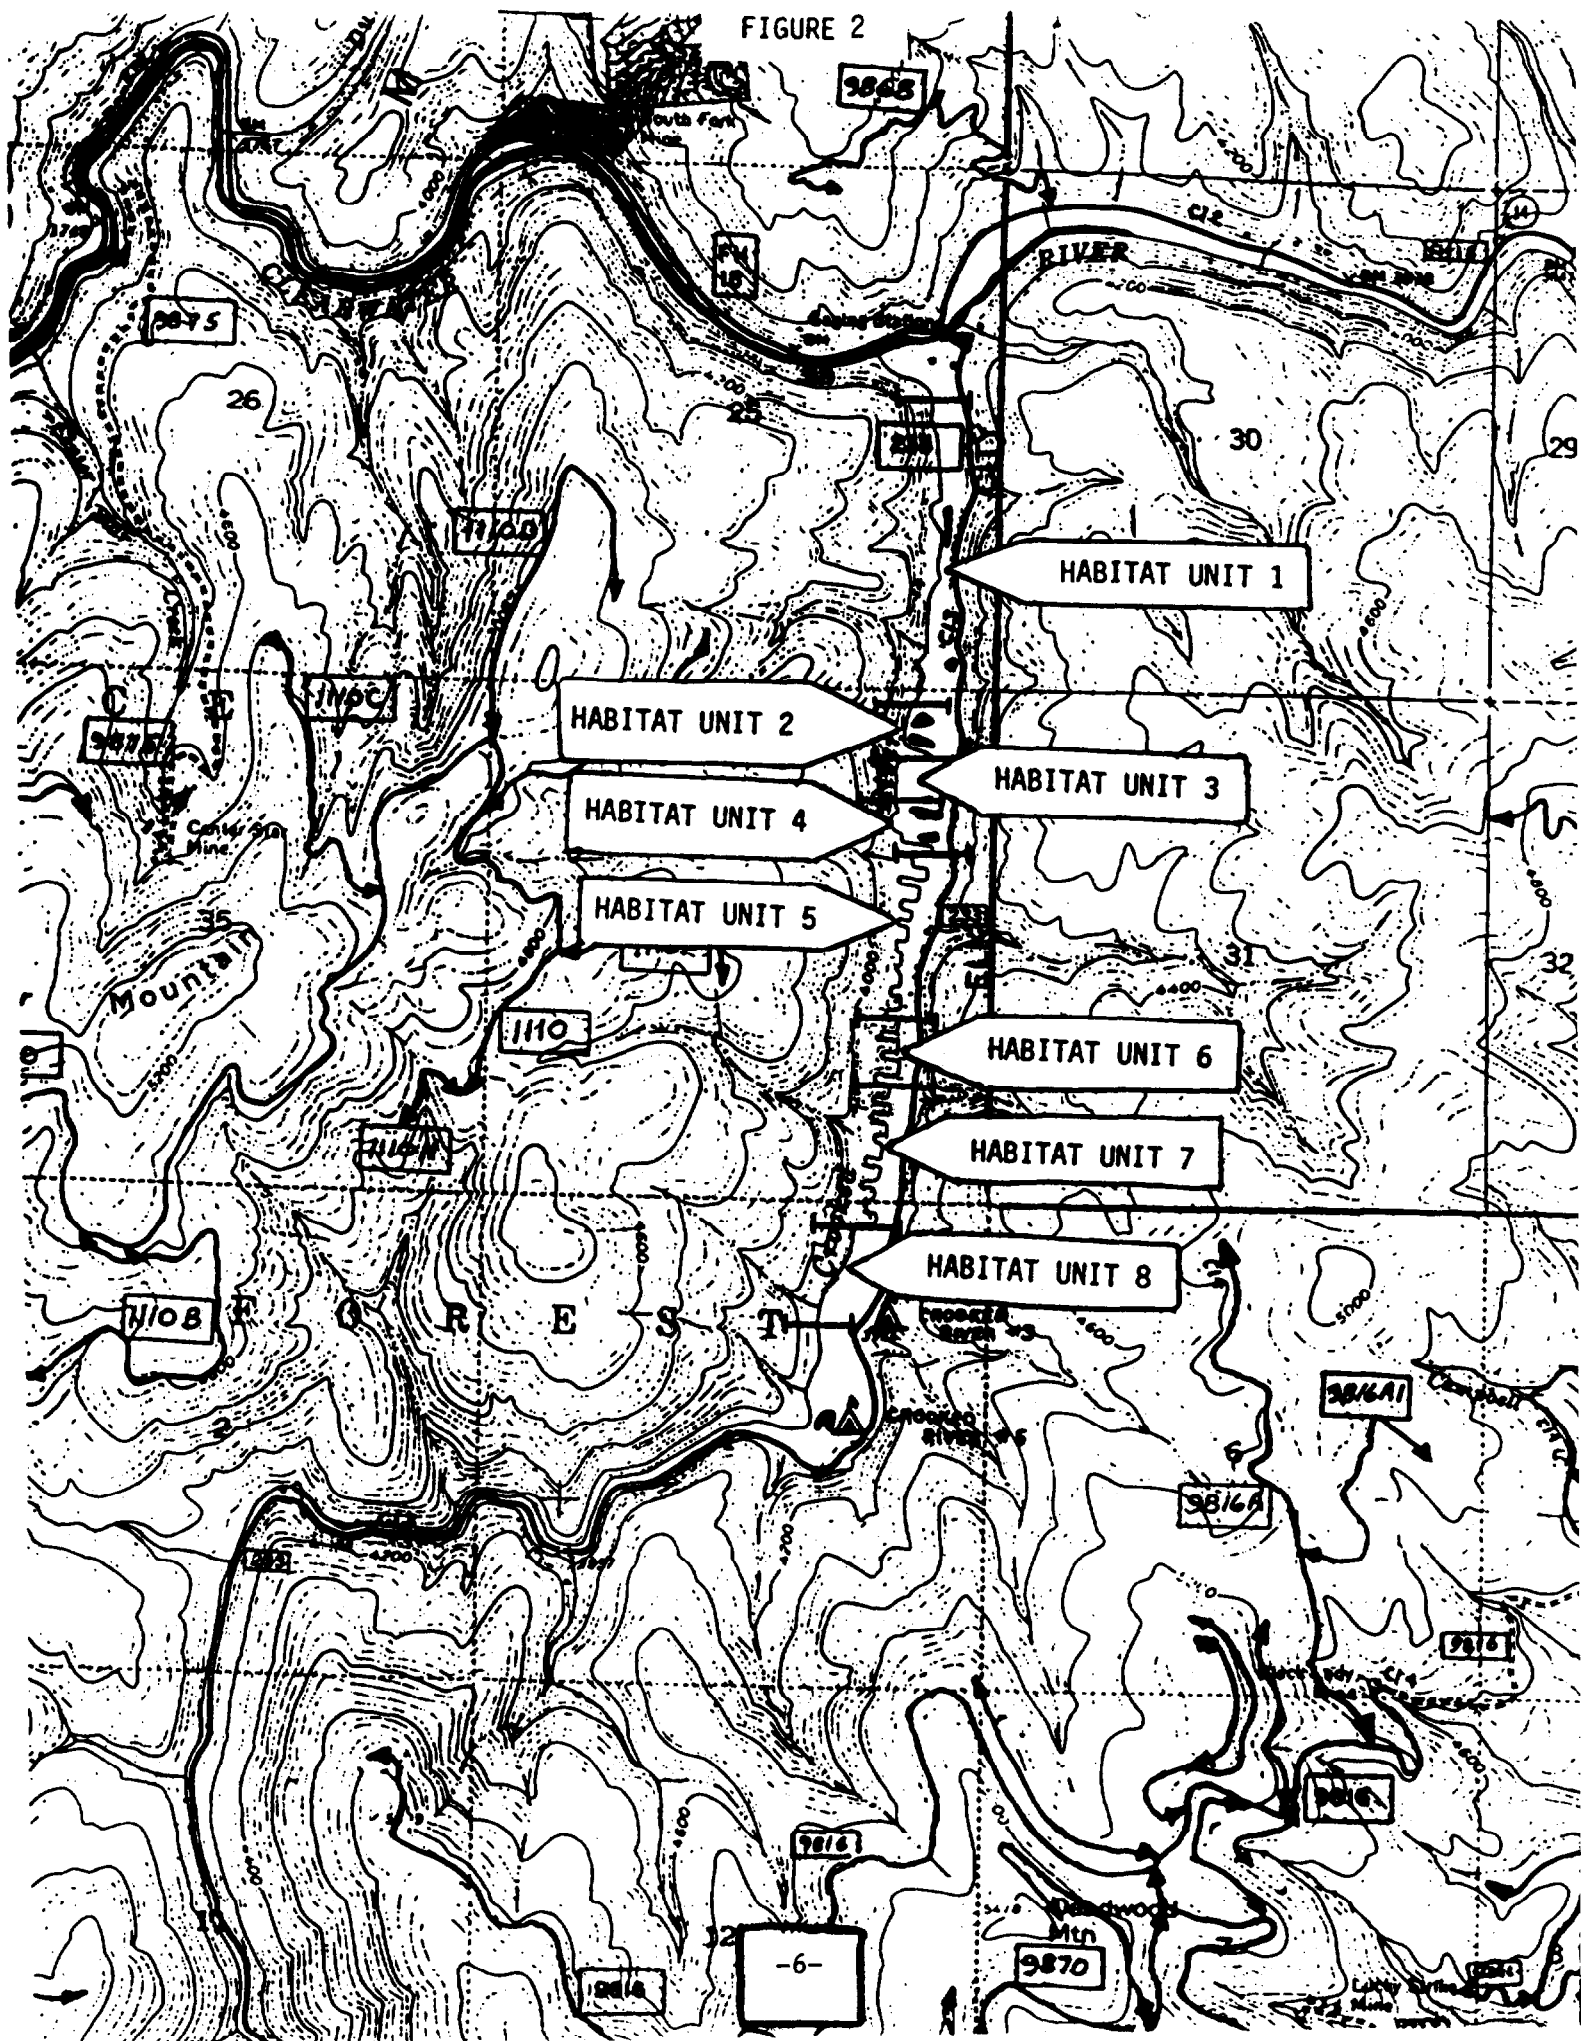
FIGURE 2

In the out-year planning process for Crooked River, Elk City District contracted with The Envirosphere Company (Contract No. 53-1295-6-33) to develop alternatives for improving fish habitat in reaches III, IV, and V. These were the stream sections lacking previous enhancement work. These reaches were subdivided into 8 habitat units based on physical differences and habitat improvement needs (Figure 2). The agencies involved met and selected the preferred alternatives for each reach.

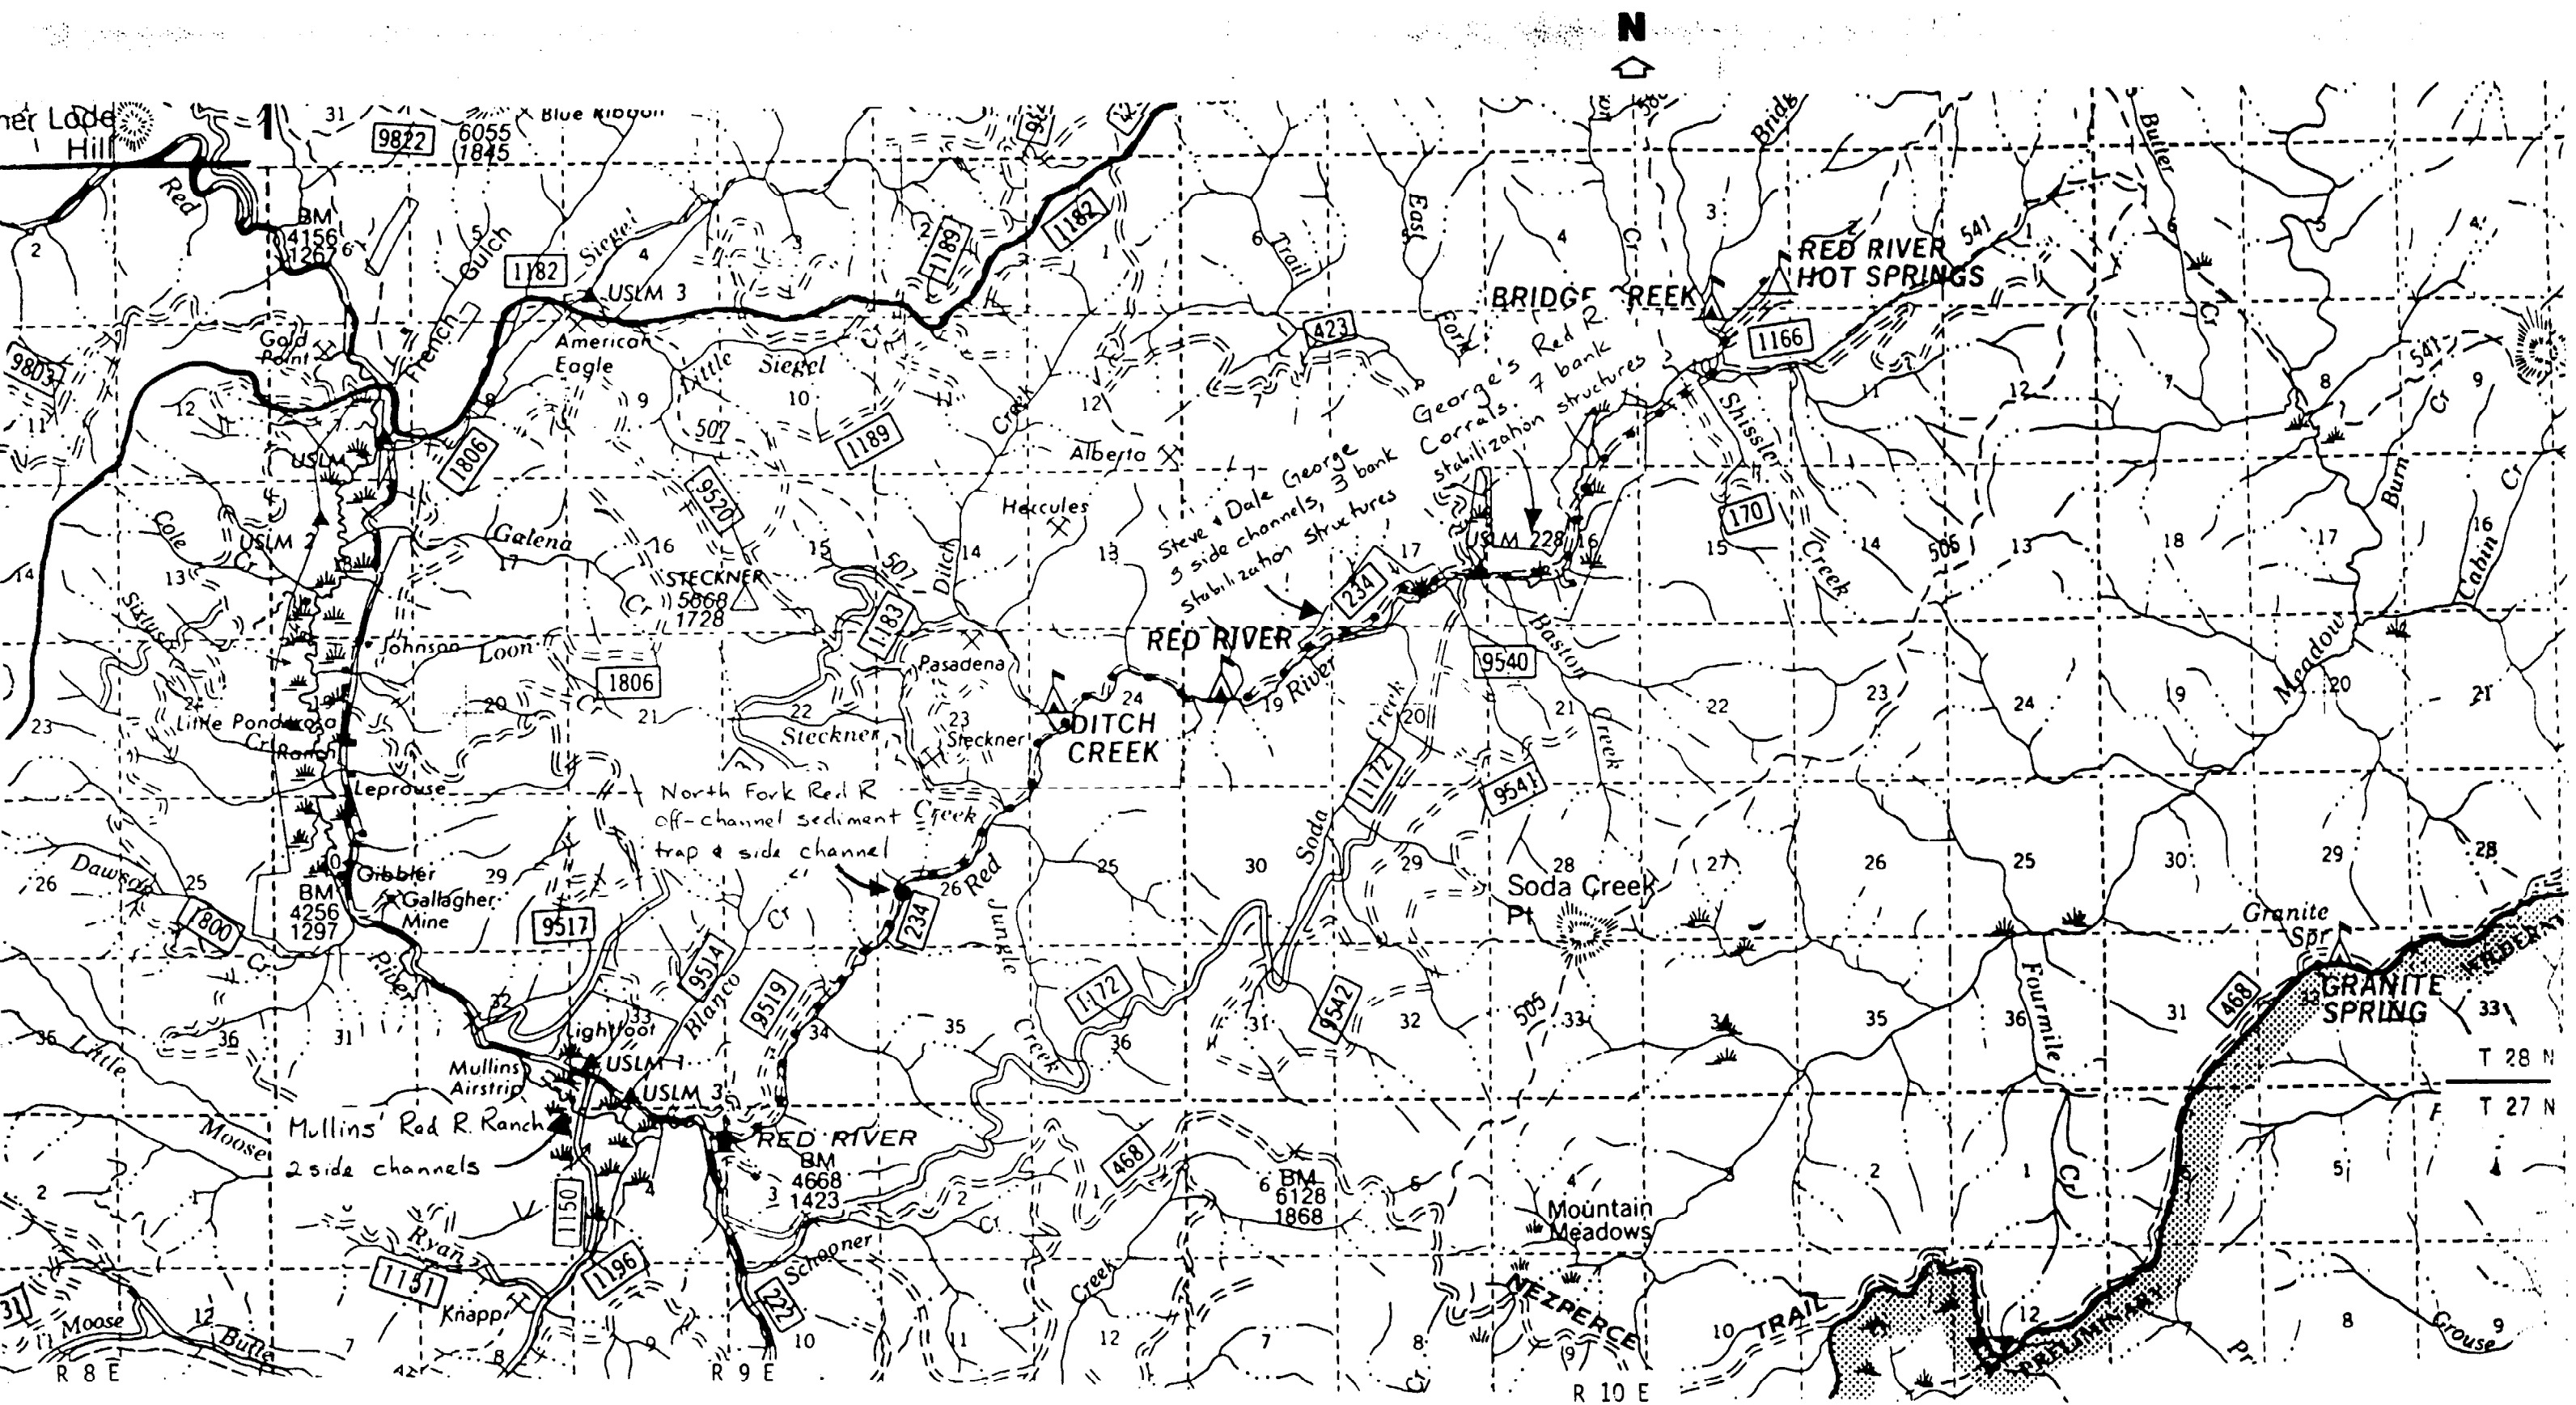
Figure 2. Location Map for 1988
habitat improvement structures
and 1989 riparian plantings

Reach V, the meadow just above Gold Point (see attached map), is currently hayed and grazed. Two sections of this very sinuous reach were straightened and widened when they were mined. The upper section (the Gibler Ranch, Figure 2) stands out in particular because it is perfectly straight, and therefore has a higher gradient than the unmined, meandering reach downstream. The transition between the mined and unmined reaches is extremely abrupt and high-velocity flow entering the series of curves downstream of the straightened reach is causing massive bank erosion.
